NWC TP, 4756

## ROCKET ASSISTED PROJECTILE (RAP) DEVELOPMENT PROGRAM

### Part 4. 5"/38 SAFETY TEST PROGRAM

**NAVAL WEAPONS CENTER**  
CHINA LAKE, CALIFORNIA \* JANUARY 1970

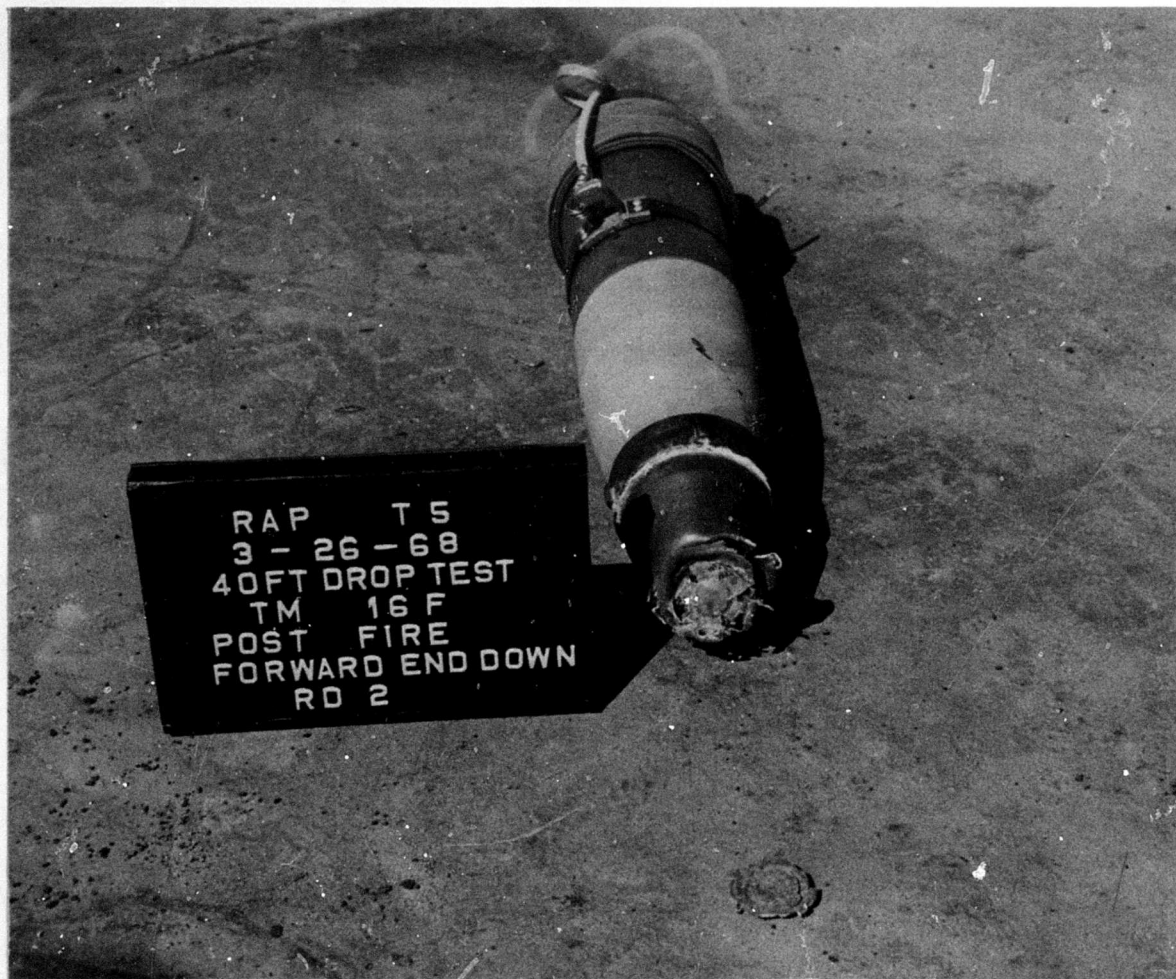
None of the projectiles detonated or deflagrated. All were considered by the Explosive Ordnance Disposal Team to be safe-to-handle for disposal by qualified personnel. An example of the fuze damage incurred on nose-down drops is shown in Fig. 3, a post-drop view of a projectile with a CVT fuze. Damage to the projectile body was most severe on horizontal drops, but was minor in all cases.

FIG. 3. View of CVT-Fuzed Projectile After Nose-Down 40-Foot Drop (LHL 142878).

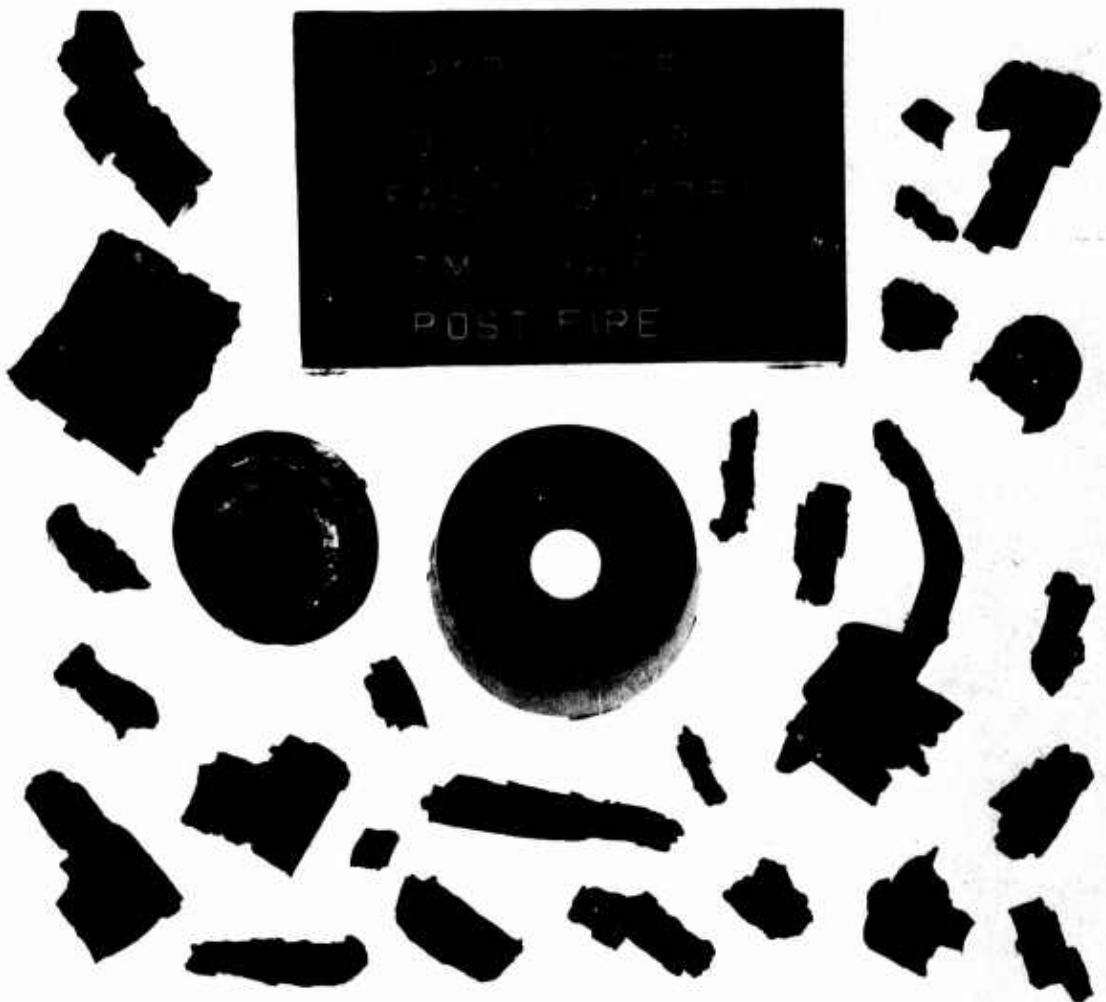
1. TM-26F - A high-order warhead reaction occurred 3 minutes 55 seconds after ignition of the fuel. The detonation completely destroyed the restraining cage and ruptured the fuel pan in several places. The rocket motor base and a 2 1/4- by 1 1/4-inch motor case fragment were found 165 feet from ground zero. Another motor case fragment 3 by 4 inches was found 153 feet from ground zero. Portions of the fuze were found at 50 feet and the fuze adapter at 188 feet. Several smaller projectile fragments were found at various distances. Figure 5 shows the recovered fragments.

FIG. 5. Recovered Fragments From TM-26F High-Order Detonation. The two circular pieces are the fuze adapter (left) and the rocket motor base (right) (LHL 142865).

2. TM-27F - A high-order warhead reaction occurred 2 minutes 40 seconds after ignition of the fuel. The size and location of the recovered fragments was similar to that of TM-26F (Fig. 5).

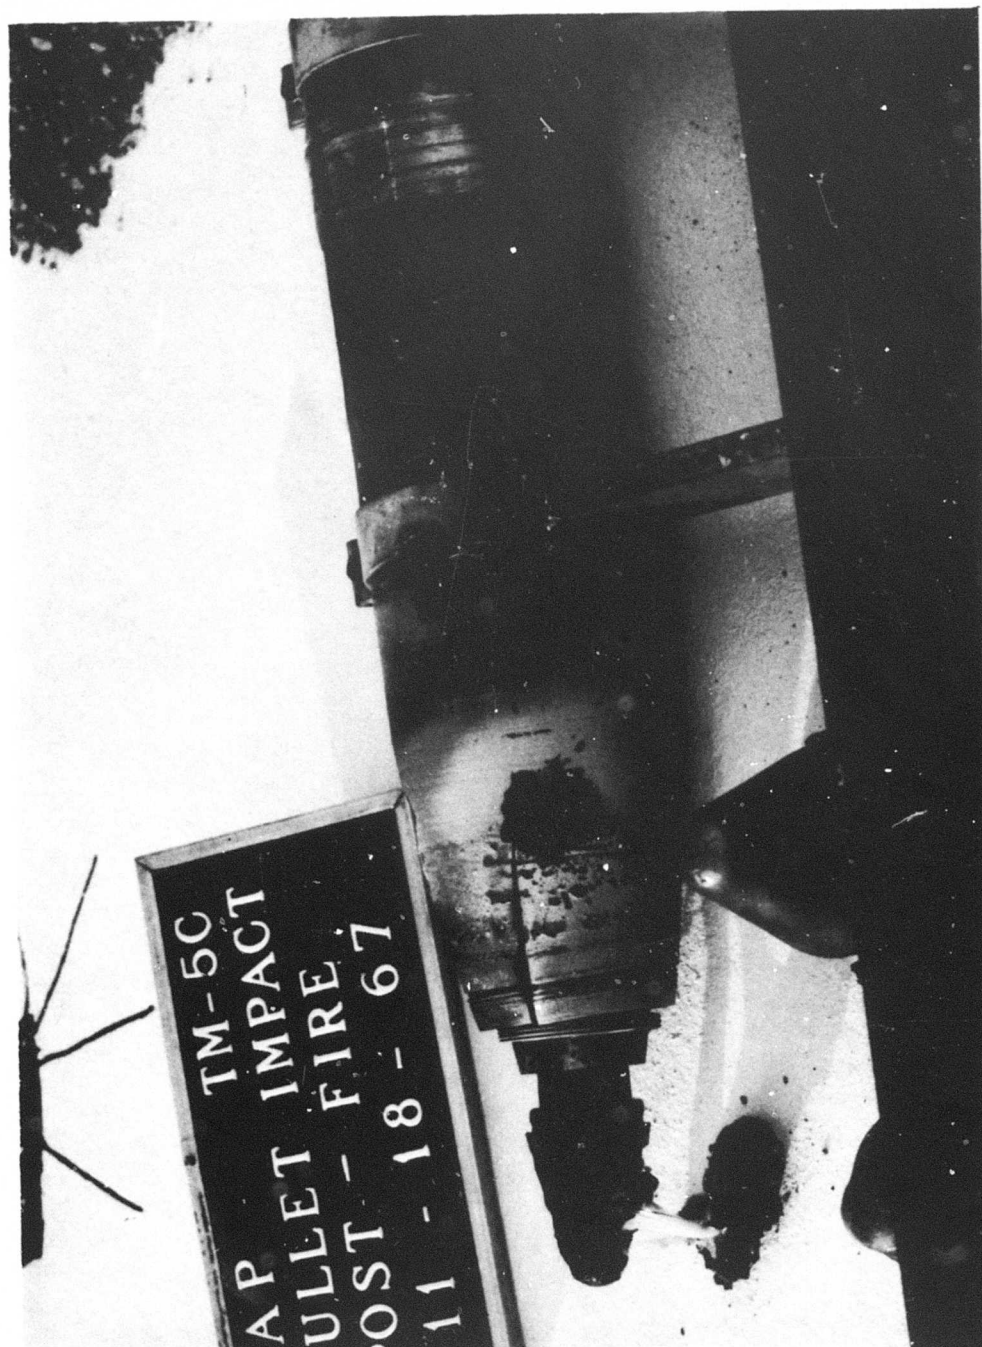
The first 20 mm round fired at TM-5C impacted the center of the projectile in the warhead/motor joint and failed to contact the explosive charge. The projectile penetrated the case for only about one-half the projectile's length. There was no detonation or deflagration as a result of this impact. The second round impacted the right side of the warhead case, causing a small flash and exposing the explosive charge. The third round penetrated the warhead 1 inch left of center and 15 1/2 inches from the base of the projectile. Upon impact the explosive charge ignited and burned for 7 minutes, at which time the auxiliary detonator exploded. After consumption of the explosive charge, the projectile was still supported by the test fixture and the rocket motor was intact. There was no exudation or burning of the propellant. Figure 8 is a post-test view of projectile TM-5C.

FIG. 8. Post-Test View of Projectile TM-5C. Two 20 mm bullet impacts, in the warhead/motor joint and a "nick" on the side, caused no reaction. The third resulted in burning of the explosive.

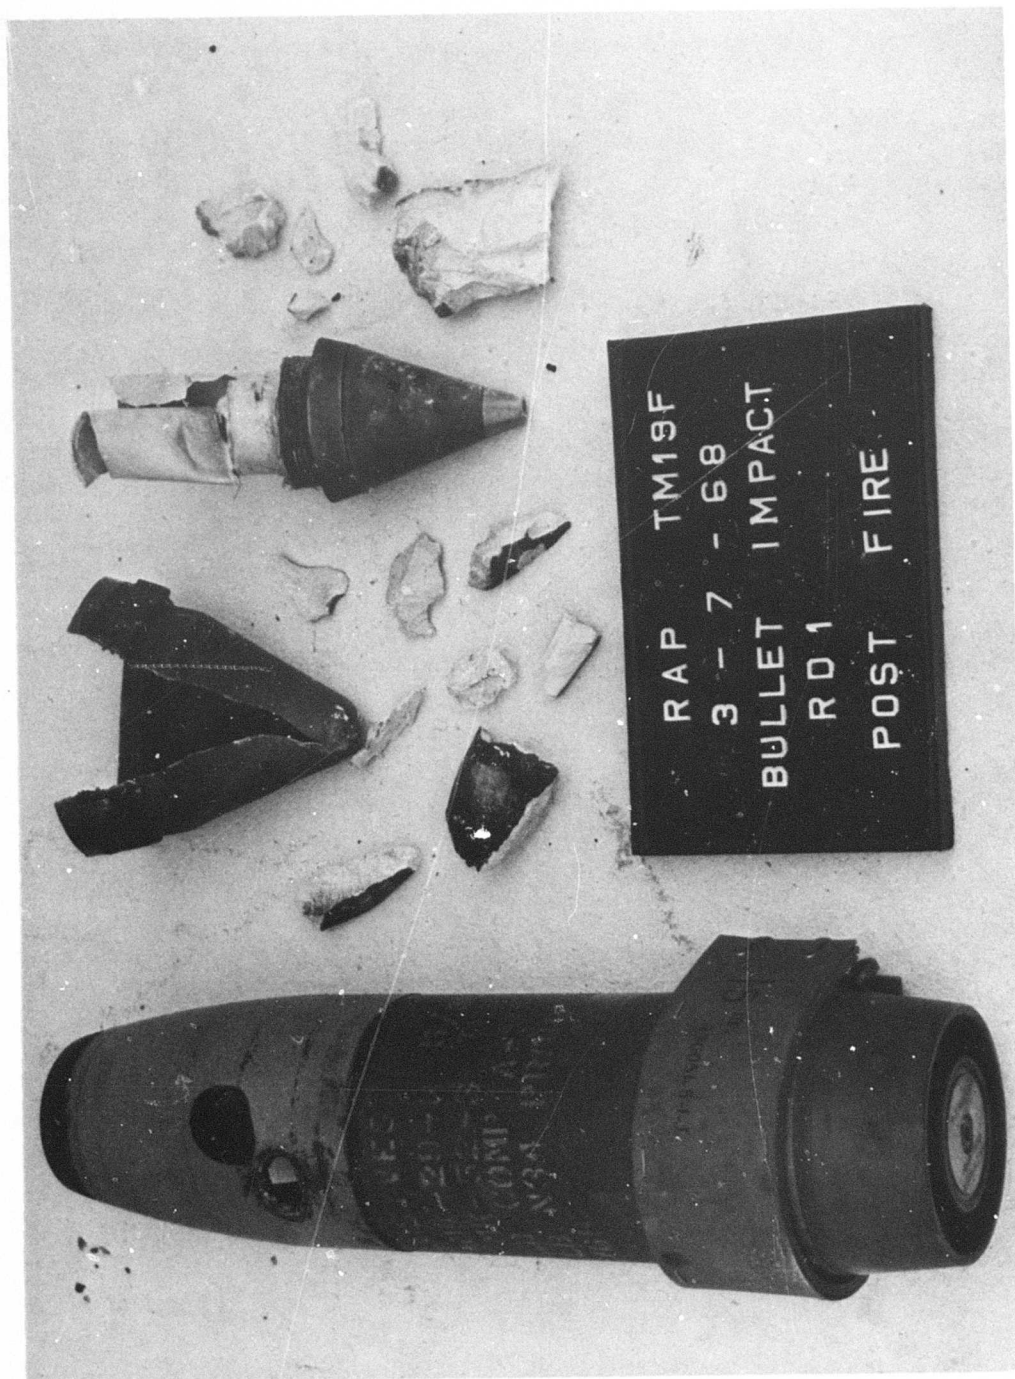
Projectile TM-19F was impacted in the warhead 1 1/4 inches to the left of center and 13 inches above the base of the rocket motor. A segment of the warhead case, approximately 6 1/4 inches by 4 inches, was separated from the warhead's aft side in relation to the entrance of the 20 mm round, and was found 60 feet from ground zero of the target area. The fuze protector cap was recovered 27 feet from ground zero and contained a 5 1/4-inch split on one side. The PD fuze was separated from the projectile and was found 21 feet from ground zero. Shattered explosive fragments were found strewn around the test area at various distances and were recovered. A small flash was observed upon impact of the 20 mm round but there was no visible evidence of ignition of the explosive. Figure 9 is a view of some of the recovered parts of the projectile; however, the aft section of the warhead case was not included in this photograph.

FIG. 9. Recovered Parts of TM-19F, Impacted in Warhead by 20 mm Projectile. The warhead incurred a pressure rupture, but no violent reaction occurred (LHL 142848).

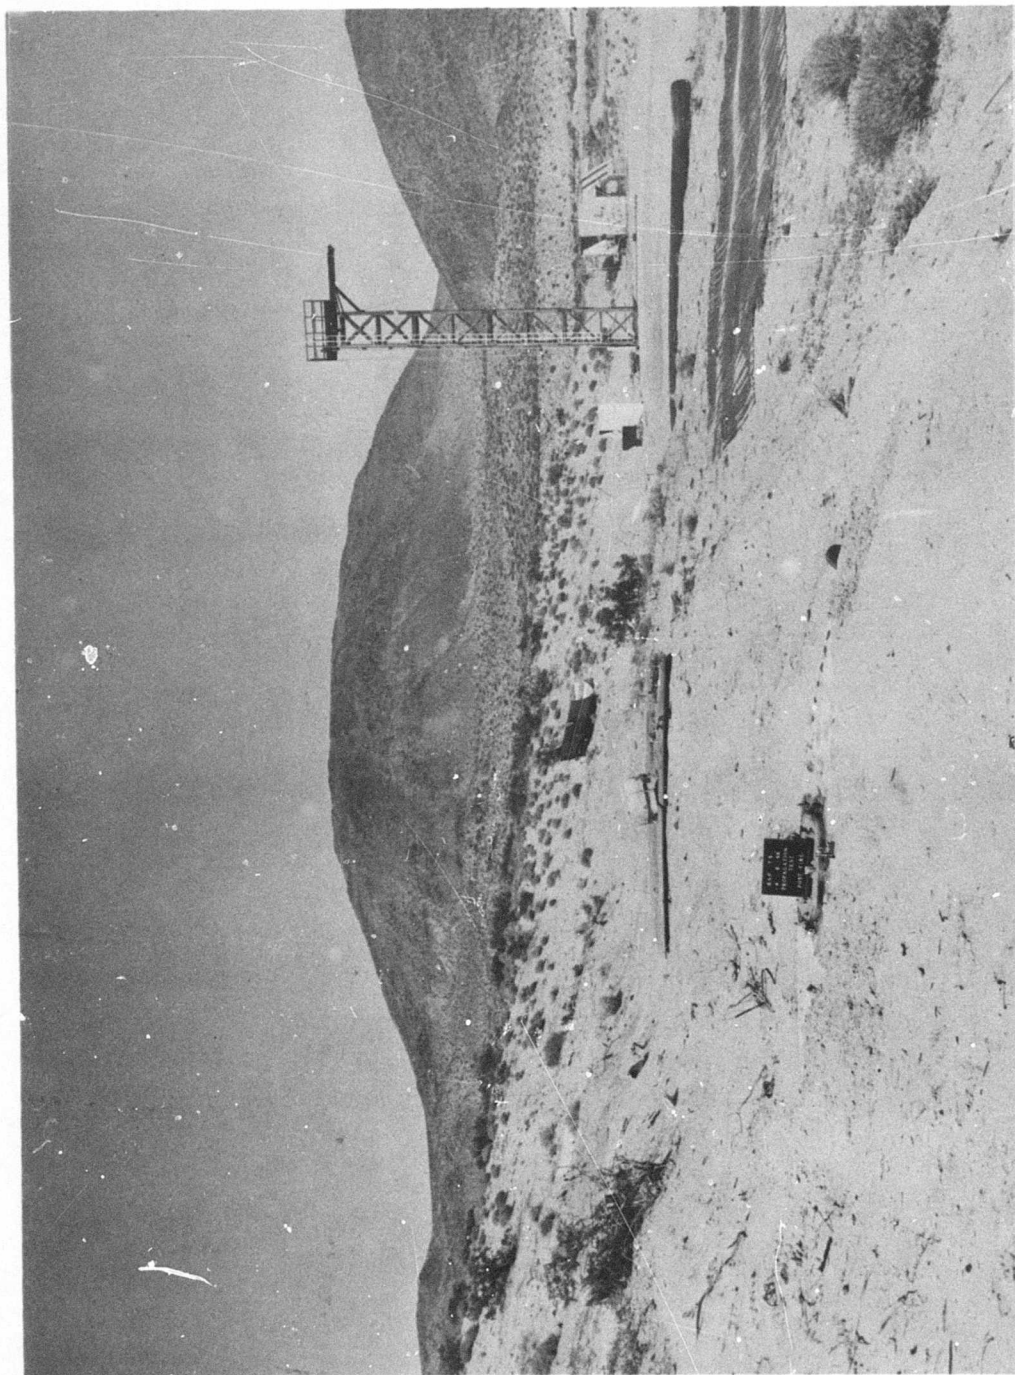
Upon application of the firing pulse, all 12 projectiles appeared to detonate simultaneously. Visual inspection of the test site revealed the following:

FIG. 12. Post-Test View of Test Site After Detonation of Donor Projectile. The gun shield was completely destroyed by an estimated nine high-order and three low-order simultaneous detonations (LHL 142884).

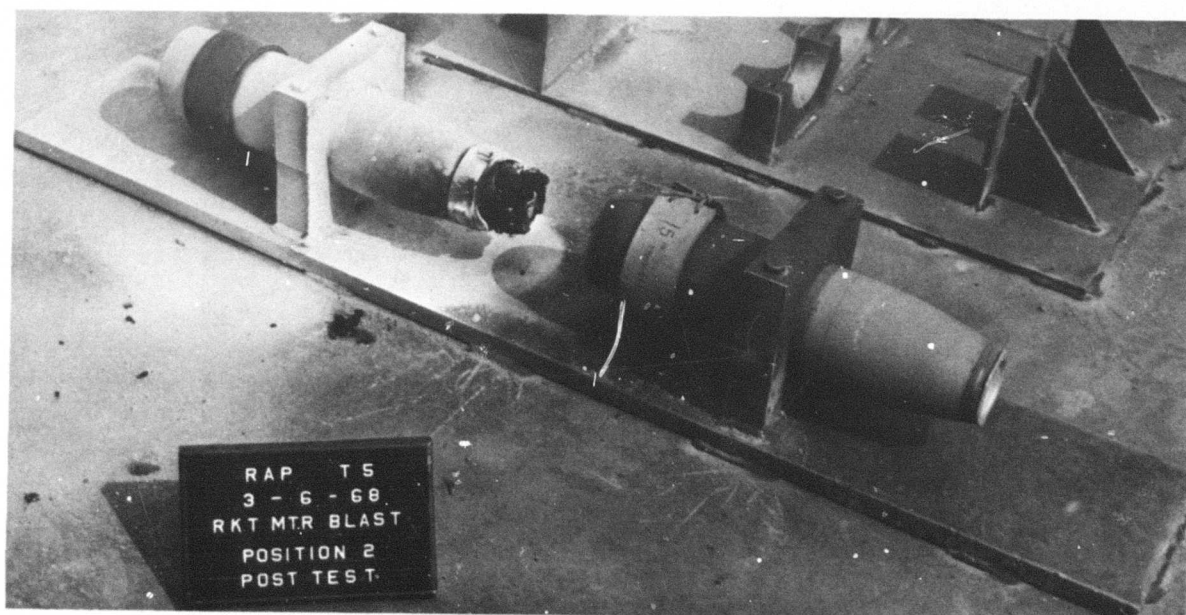
2. Position 2 - The rocket motor of the donor projectile, TM-35F, functioned normally and burned for approximately 7 seconds, with the flame impinging upon the fuze protector cap of the acceptor, TM-32F, for the full burn period. The fuze protector cap and CVT fuze of the acceptor projectile were burned away back to the point where the fuze protector cap threads engage those of the projectile. There was a slight discoloration on the ogive of the acceptor projectile. Figure 16 is a post-test view of the projectiles.

FIG. 16. Post-Test View of Rocket Motor Blast Test, Position 2, Showing Damage to Fuze of Acceptor (Left) (LHL 142833).

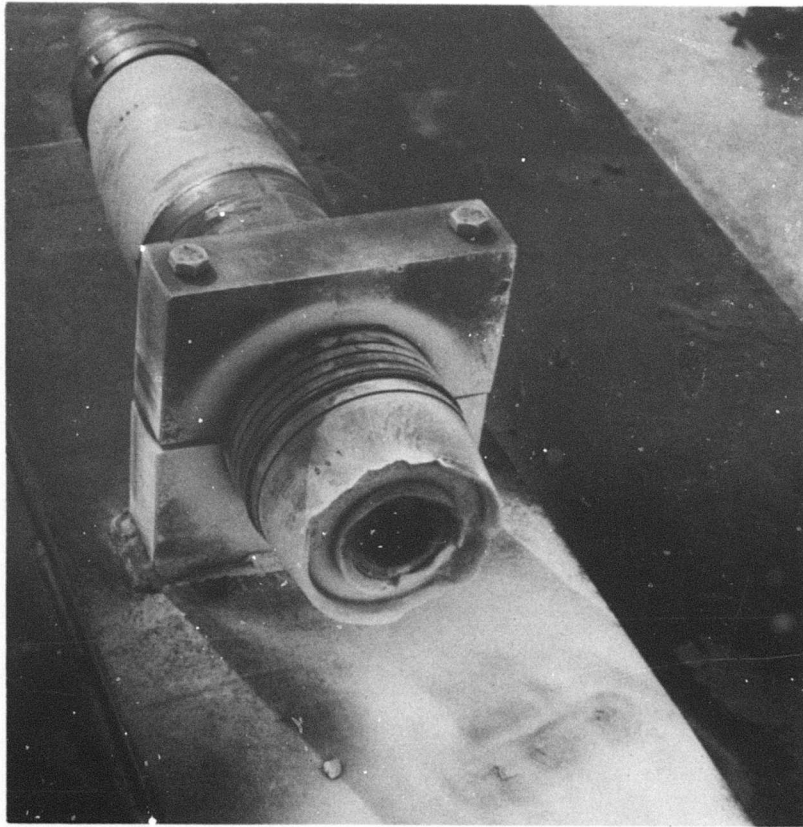
3. Position 3 - The donor motor, TM-36F, ignited normally, with the flame impinging on the base of the acceptor projectile, TM-33F. At about 1 second after ignition of the donor rocket motor, the weld holding the saddle block to the plate broke, thereby allowing the donor to launch itself into the hillside 21 feet from ground zero. However, the acceptor projectile remained contained in its saddle block. Approximately 23 seconds after ignition of the donor, which corresponds to the igniter delay time, the acceptor's rocket motor ignited and burned for the normal length of time. Figure 17 is a view of the aft end of the acceptor projectile; erosion from the blast of the donor is evident.

FIG. 17. Post-Test View of Rocket Motor Blast Test, Position 3, Showing Damage to Base of Acceptor. The acceptor ignited after the 23-second delay time (LHL 142831).

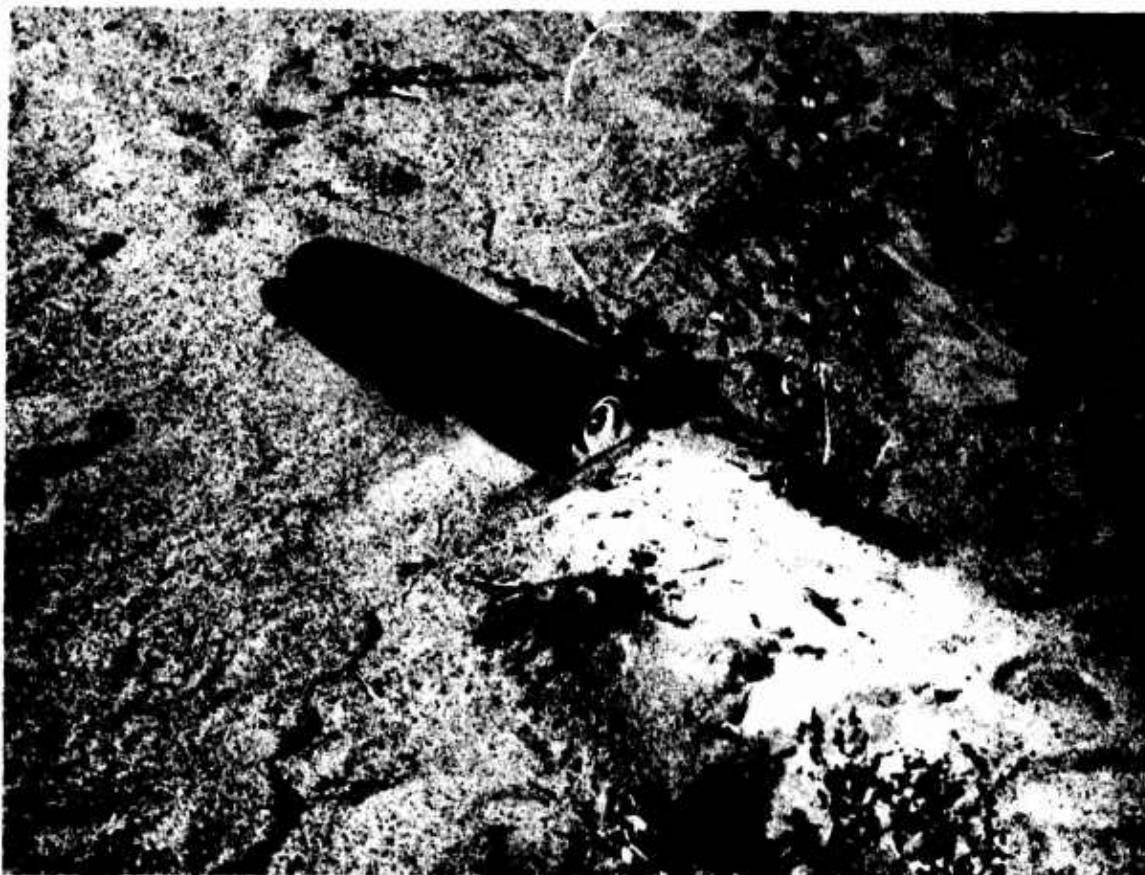
The projectile was placed, unrestrained and in a horizontal position, in a wooden trough 4 1/2 feet high. The igniter was initiated and the rocket motor ignited normally after the 23-second delay. The projectile launched itself downrange in a horizontal position with a slight nose-down angle, impacted flat at about 300 feet from ground zero, again at 690 feet, and again at 1,200 feet, at which time the nose of the projectile dug into the ground causing the projectile to tumble end-over-end for the remainder of the flight. It came to rest, with the motor still burning, at a point 2,620 feet from ground zero and 20 feet to the right of the flight path. Figure 18 shows the projectile at the final resting place.

FIG. 18. Aft-End View of TM-9C After Unrestrained-Projectile Ignition Test. The motor burned for a short time after the projectile came to rest 2,620 feet from the launch point. The fuze remained in the safe condition.

The projectile body exhibited very little damage as a result of the test. There was a definite indication of the first impact on the ogive of the warhead and the graphite nozzle was missing. A sharp report was heard coincident with the first impact, indicating that at this point in the flight the motor overpressurized and expelled the nozzle. The fuze was shattered and carried away on the third impact. Fragments of the fuze were found scattered over this area. The fuze adapter and AD fuze were still in the nose of the projectile. The AD fuze arming mechanism was located and was found to be in the safe condition.

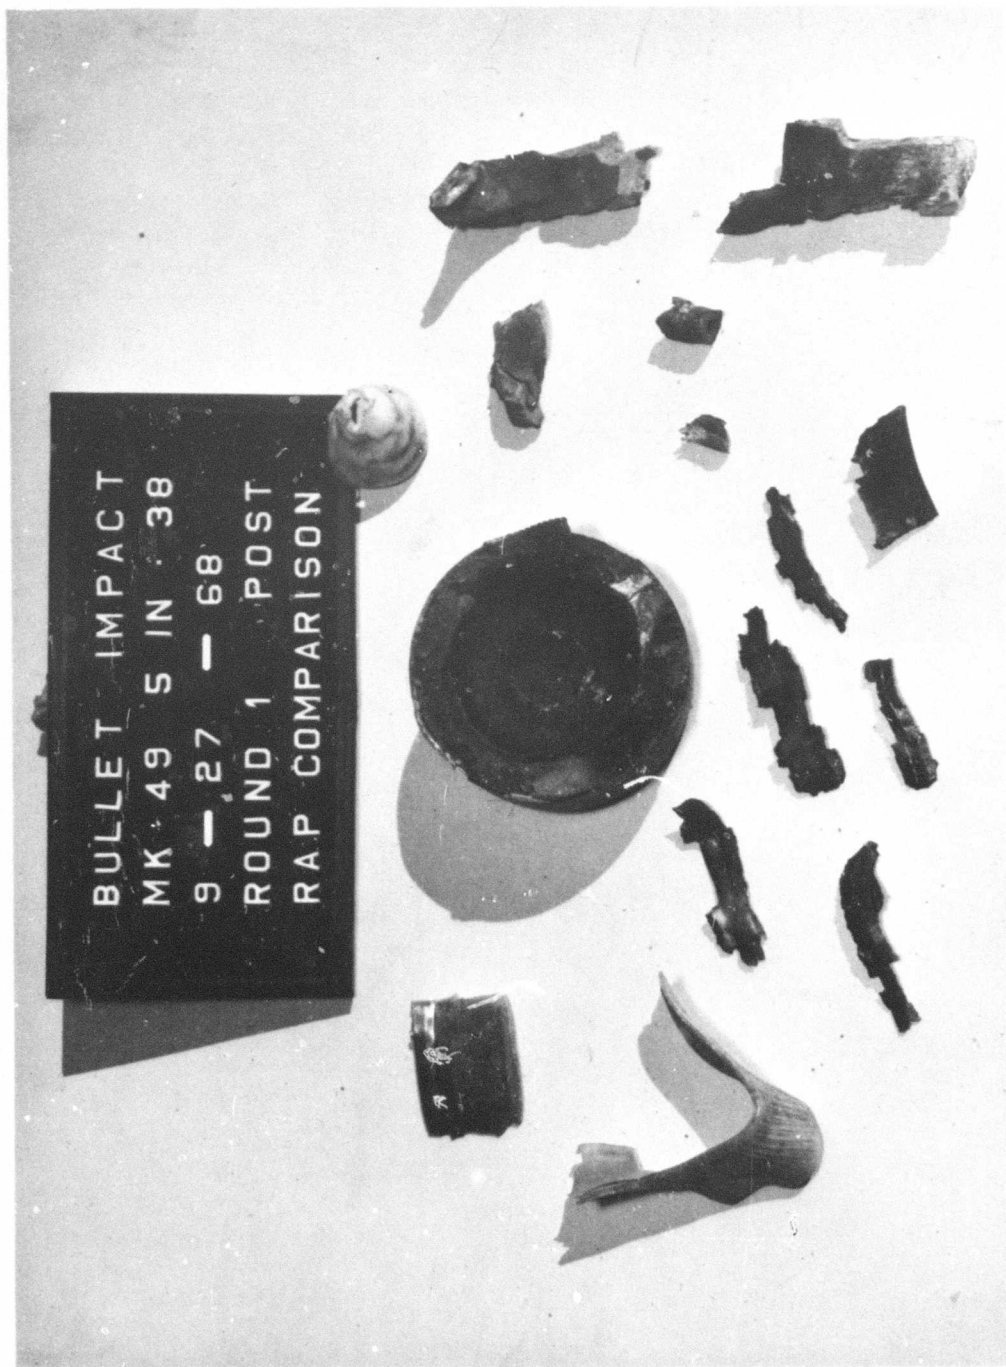
1. 5"/38 projectile No. 1 suffered a low-order detonation.
2. 5"/38 projectile No. 2 suffered a deflagration.
3. 5"/38 projectiles No. 3 and 4 neither deflagrated nor detonated.
4. 5"/54 projectiles No. 5 through 8 suffered deflagrations.

FIG. 19. Recovered Fragments of Mk 49 Mod 1  
5"/38 Projectile No. 1 (LHL 136354).

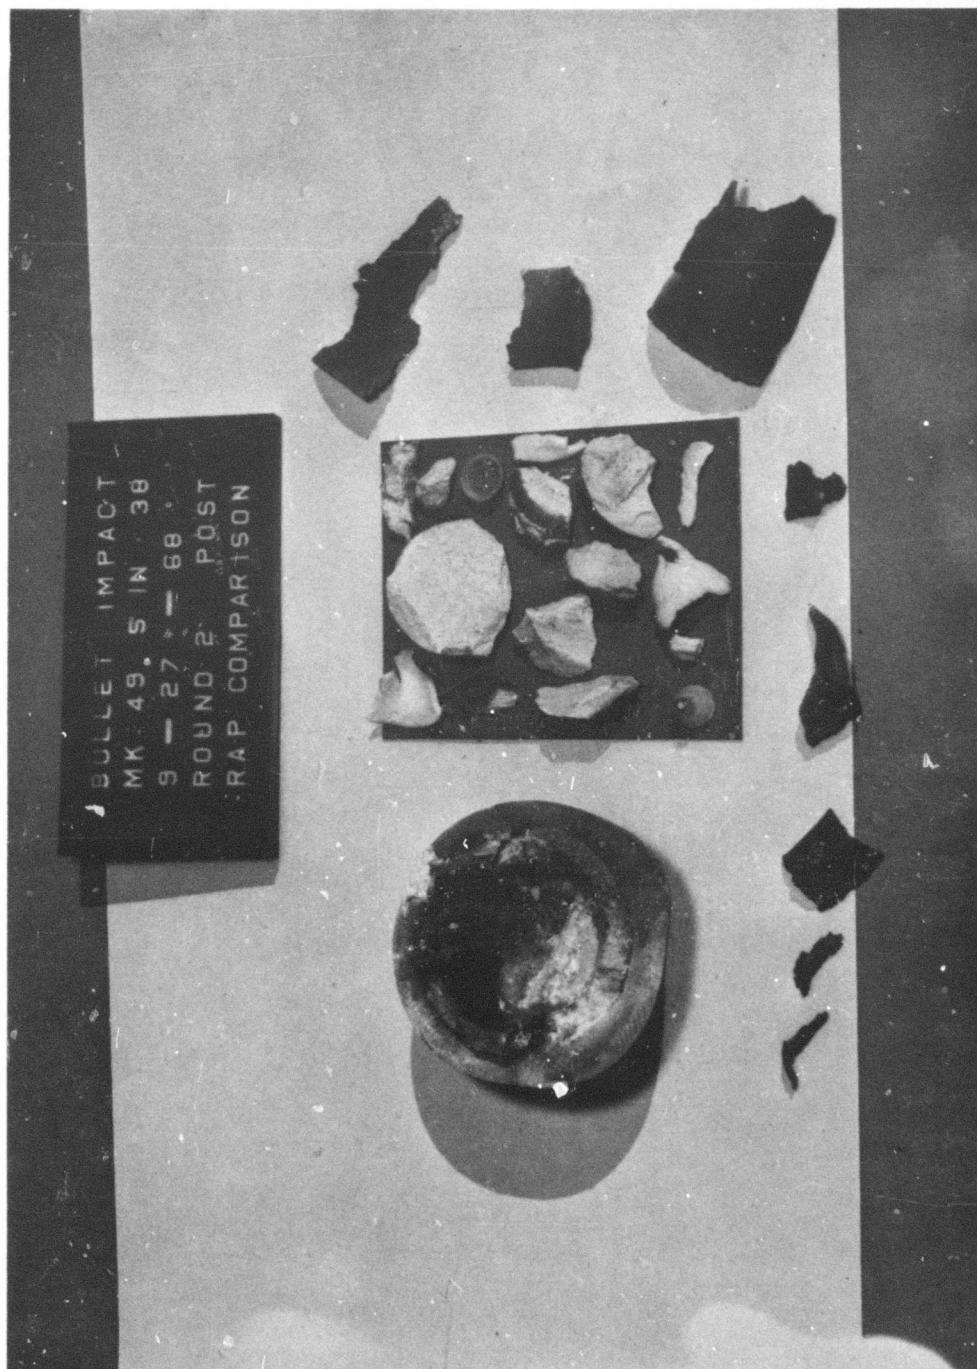
1. Smoke cloud and audible report at impact.
2. Projectile base and rotating band still intact at ground zero.
3. Explosive fragments found over an area 10 feet in diameter (Fig. 20).
4. Projectile fragments recovered in an area of 118 yards radius (Fig. 20).
5. Fuze, still fairly intact, found 90 yards from ground zero.

FIG. 20. Recovered Fragments of Mk 49 Mod 1  
5"/38 Projectile No. 2 (LHL 136345).

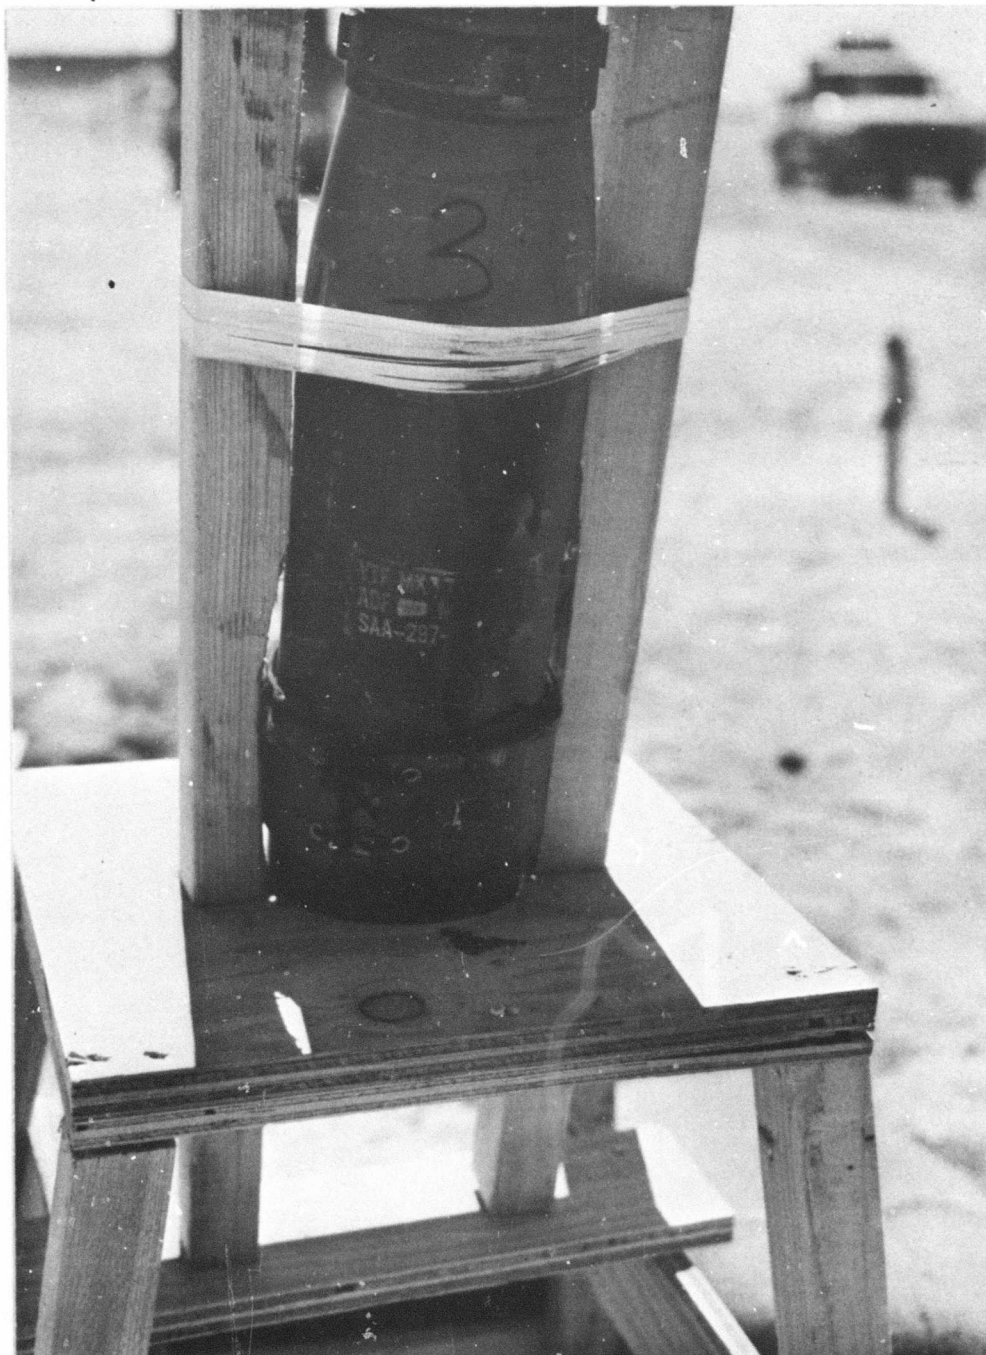
1. No smoke or audible report at impact.
2. Penetration of outer case upon entry but did not exit.
3. Aft side of case split approximately 4 inches (Fig. 21).
4. Visible evidence of slight burning both at the point of entry and 4-inch split.

FIG. 21. Post-Test View of Aft Side of Case,  
Mk 49 Mod 1 5"/38 Projectile No. 3 (LHL 136356).

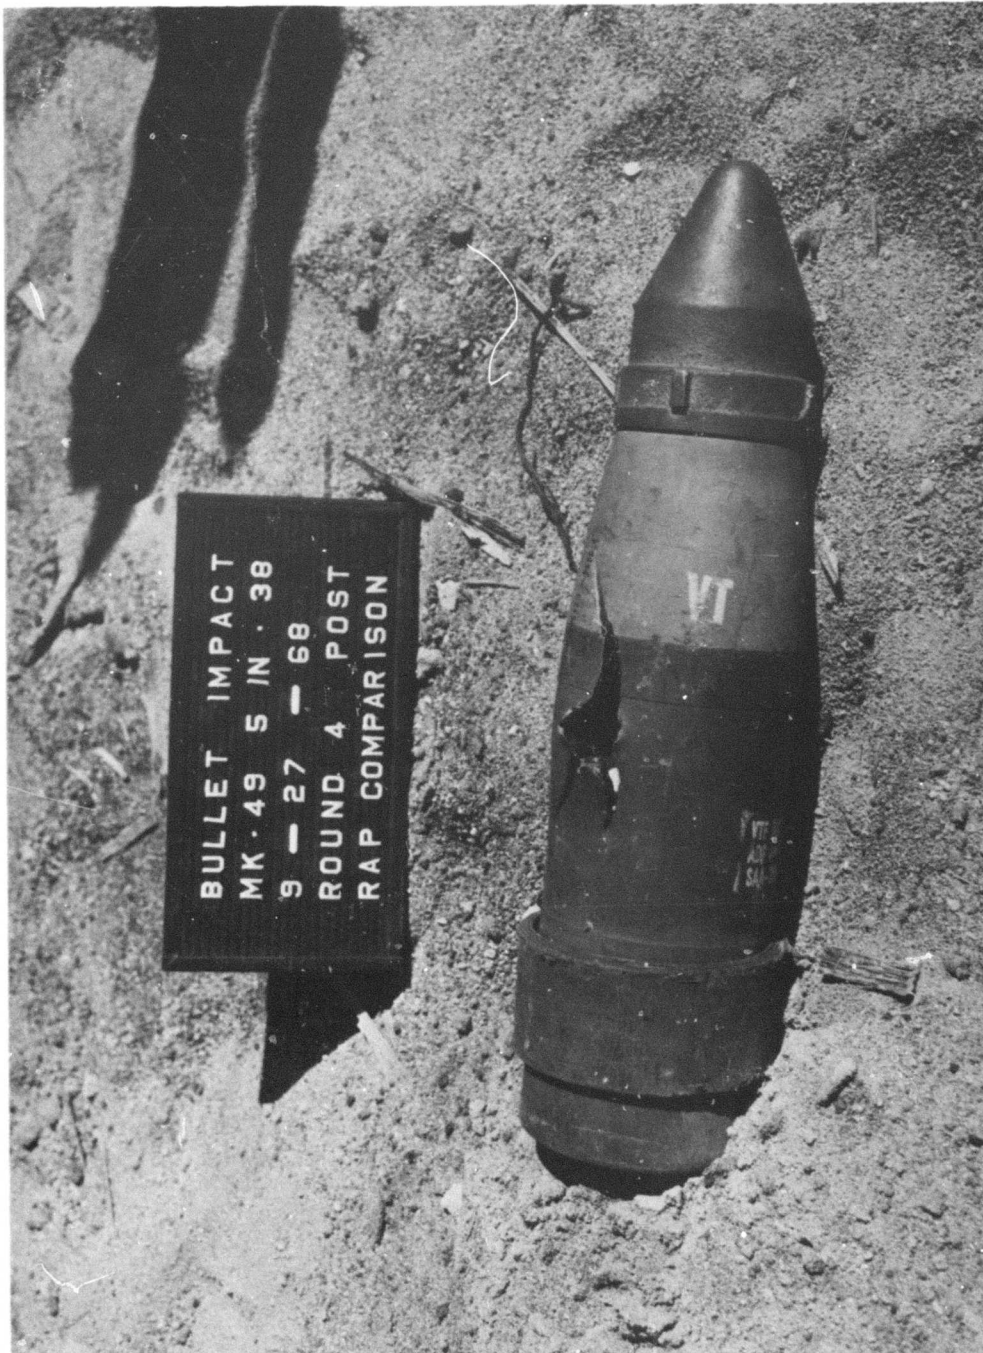
1. No smoke or audible report at impact.
2. Complete penetration, splitting aft side of case (Fig. 22).
3. No evidence of burning.
4. Minute fragments of explosive at ground zero.

FIG. 22. View of Exit Side of Mk 49 Mod 1  
5"/38 Projectile No. 4 (LHL 136348).

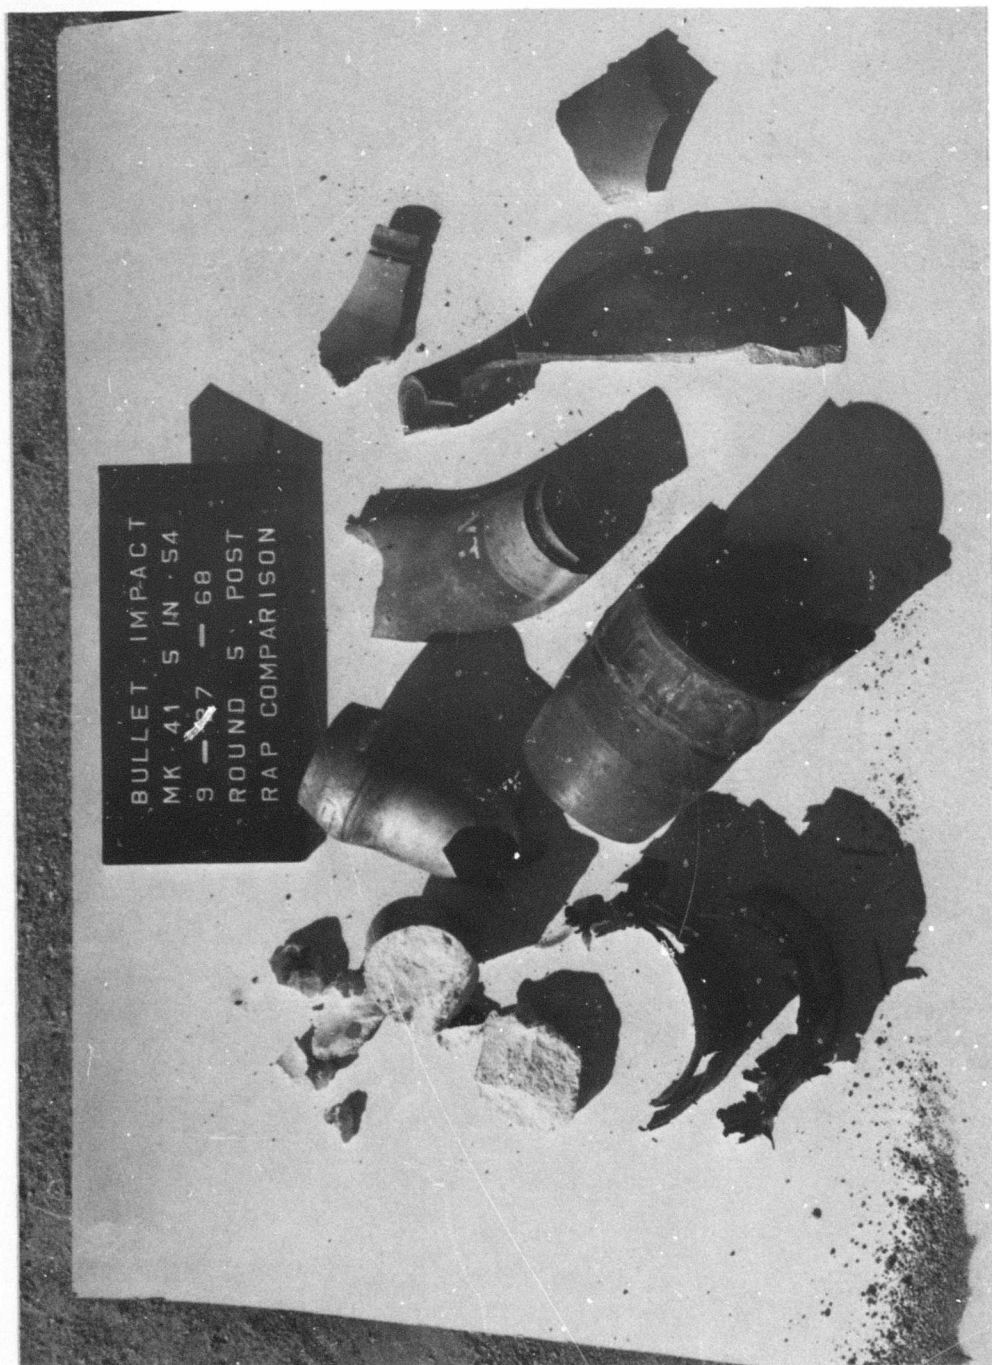
4. Large projectile case fragments and explosive fragments found 140 yards from ground zero (Fig. 23).
5. Fuze, still fairly intact, found 63 yards from ground zero.

FIG. 23. Recovered Fragments of Mk 41 Mod 0  
5"/54 Projectile No. 5 (LHL 136349).

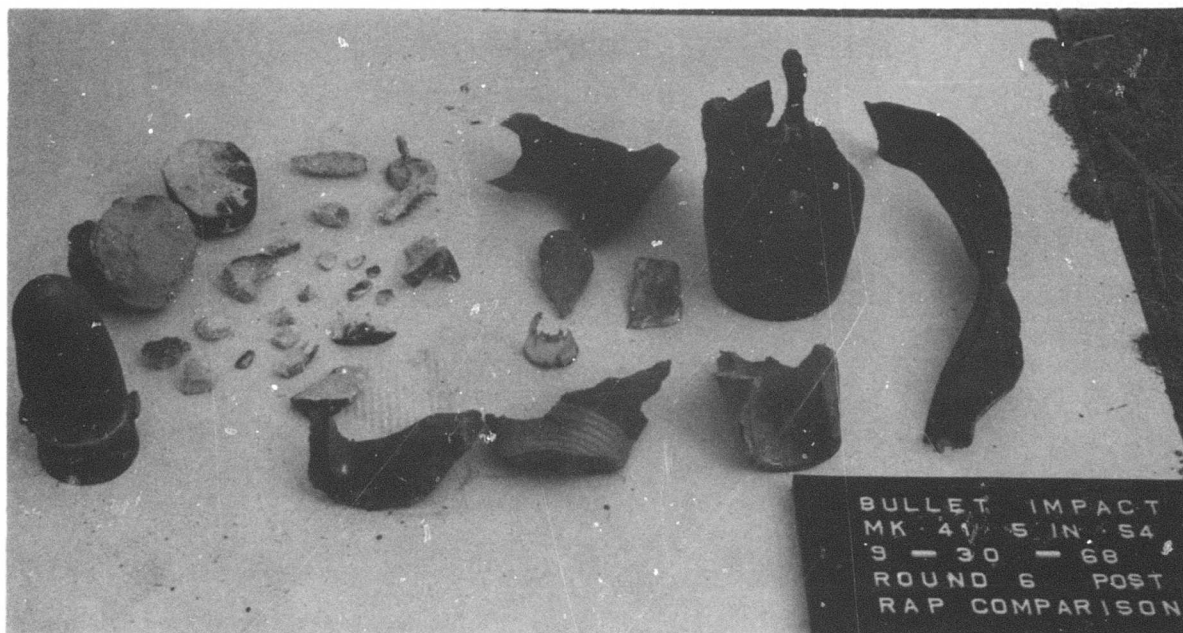
1. Smoke cloud and audible report at impact.
2. Projectile base found intact, 6 feet to rear of support stand.
3. Large explosive fragments found at ground zero.
4. Large segment of rotating band found 8 feet from ground zero.
5. Projectile case fragments and explosive fragments found within a radius of 75 yards of ground zero (Fig. 24).
6. Fuze found partially intact, 84 yards from ground zero.

FIG. 24. Recovered Fragments of Mk 41 Mod 0  
5"/54 Projectile No. 6 (LHL 136368).

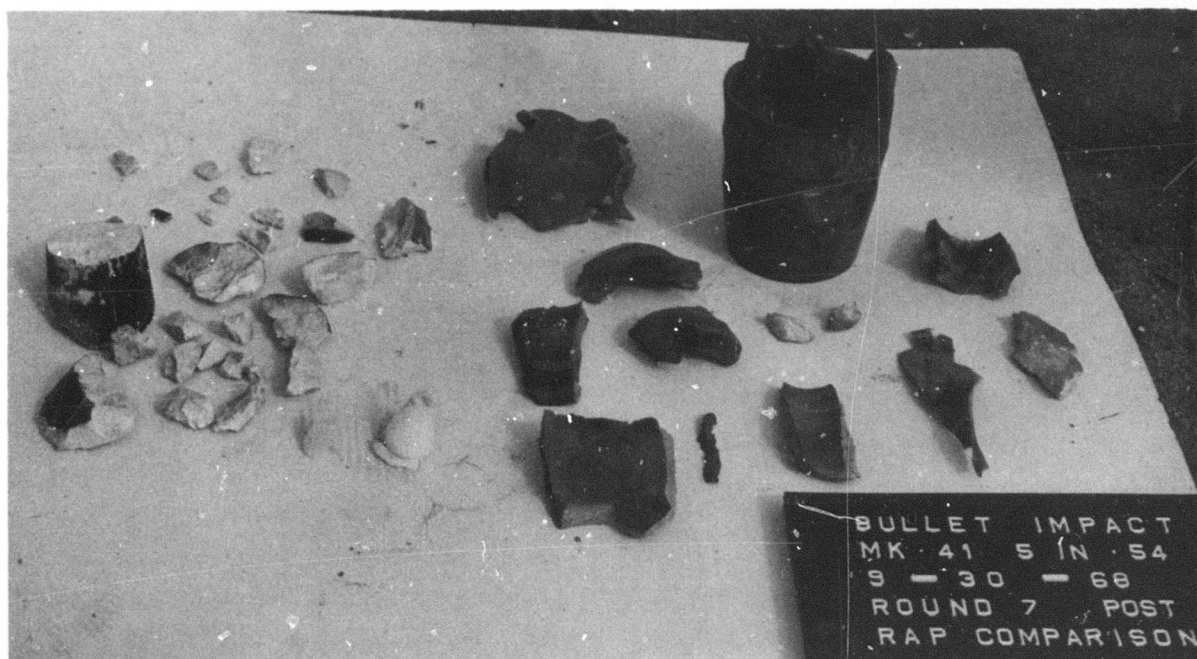
1. Smoke cloud and audible report at impact.
2. Projectile base intact, with the rotating band in place, found 10 feet from ground zero.
3. Large fragments of explosive found at ground zero (Fig. 25).
4. Projectile case fragments and small fragments of explosive were found within 52-yard radius of ground zero (Fig. 25).
5. Fuze, still intact, found 60 yards from ground zero.

FIG. 25. Recovered Fragments of Mk 41 Mod 0  
5"/54 Projectile No. 7 (LHL 136366).

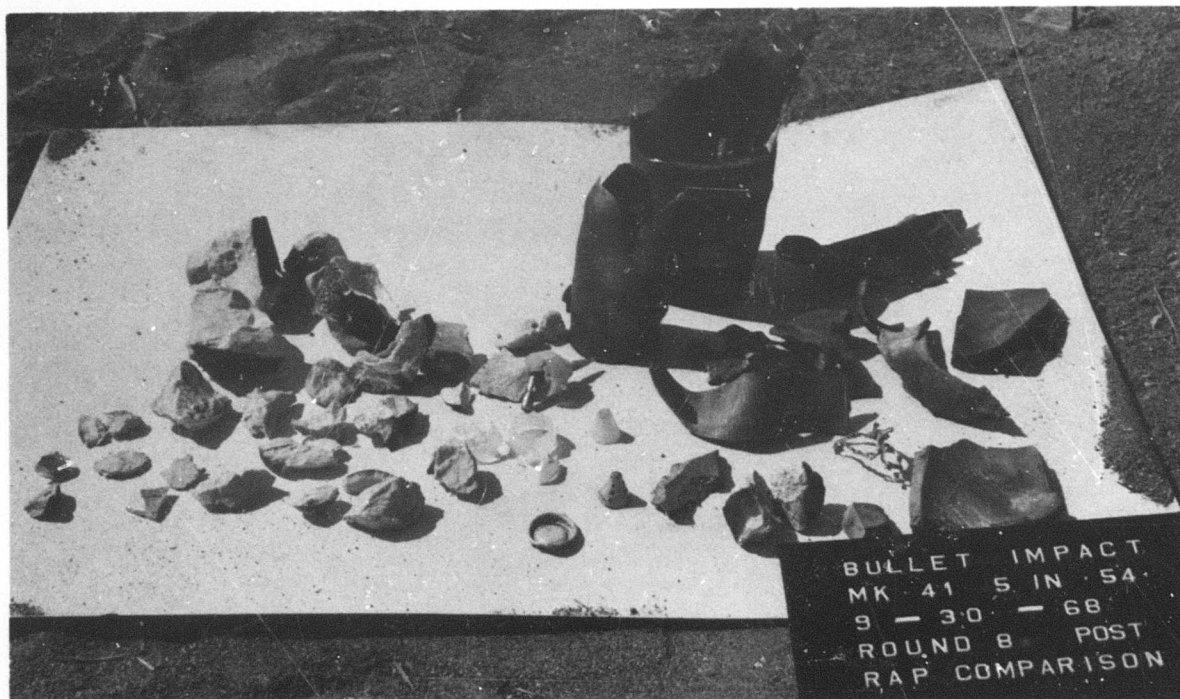
1. Smoke cloud and audible report at impact.
2. Projectile base found 10 feet to rear of support stand and intact.
3. Large quantities of explosive found in the area of ground zero (Fig. 26).
4. Fragments of projectile case and explosive found within a 145-yard radius of ground zero (Fig. 26).

5. Fuze, with forward section missing, found 82 yards from ground zero.

FIG. 26. Recovered Fragments of Mk 41 Mod 0  
5"/54 Projectile No. 8 (LHL 136365).
